# TOWARDS RAIN EROSION CHARACTERIZATION OF WIND TURBINE BLADE COATINGS: EFFECT OF THE IN-MOULD CURING CONDITIONS ON THE COATING-LAMINATE INTERPHASE

**Keywords:** In-mould coatings, Resin infusion, Curing characterization, Rain erosion, Leading edge coatings.

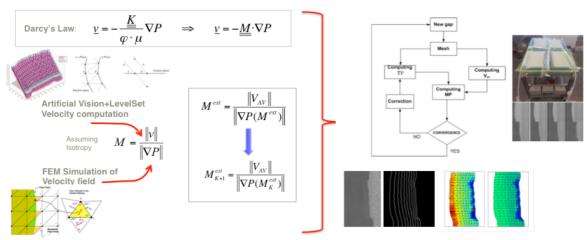
**Figure 3.** Estimation of the flow induced effect of the coating curing in the material characterization during filling: proposed algorithm (left) and experimental set up with results (right)

A mixed numerical/experimental technique based on artificial vision is used to estimate the induced effect of the surface coating curing in the laminate impregnation and the flow front advance during filling. The procedure iterates the value of the estimated local material parameters M in the physical numerical simulation until it matches the evolution of the experimentally measured flow front data (see Fig. 3). Computation of velocities at the flow front can be estimated by means of the distance and time between consecutive flow fronts. In this work [10] a level set approach is employed to compute the vent distance field. It can be observed so that the curing degree discontinuity of the coating areas can be identified by means of a deep change on the flow front velocity and hence M variation can be estimated and the flow behaviour characterised.

The experiments have been conducted by filling a 2D rectangular mould. Two different curing conditions for the gel coat were used in order to generate differences in the impregnation and flow advancement of the resin in the dry preform during filling. Coat 1 and Coat 2 are characterised previously by performing a measure of the degree of conversion of the polymerization reaction of the polymer matrix (see Fig. 4). The degree of conversion ( $\alpha$ ) is obtained by measuring the residual enthalpy DH (J/g) with a Differential Scanning Calorimetry (DSC). The samples are quantified and outlined in Fig. 3.

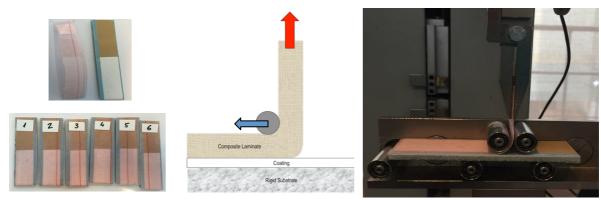
Figure 6. Developed peeling testing for interphase coating-laminate adhesion response quantification

Wind turbine blade applications require an optimum interphase adhesion for mechanical performance and durability reasons. Distinctive mechanical testing are shown in order to assess the macroscopic behaviour of the laminates and its relation with the coating curing conditions. In Fig. 5 pull-off strength testing of the samples show the failure in the composite laminate and hence the capability of the coating to assure the required target strength. There is a lack of information regarding the curing effect on the interphase. Figure 6 shows a specially-developed peeling test for interphase coating-laminate adhesion response quantification. The samples are moulded over a rigid substrate, where the coating is bonded with a special adhesive and hence the differences on the adhesion laminate-coating depending on its curing can be measured. In Fig. 8 it can be observed in microscopy images how the less-cured coating (Coat 2) defines a broader interphase area due to a bigger chemical adhesion. Figure 7 shows the failure load for peeling interphase adhesion testing. Coat 1 (cured) has an average value 19.3 N and Coat 2 (tack) of 25.1 N.

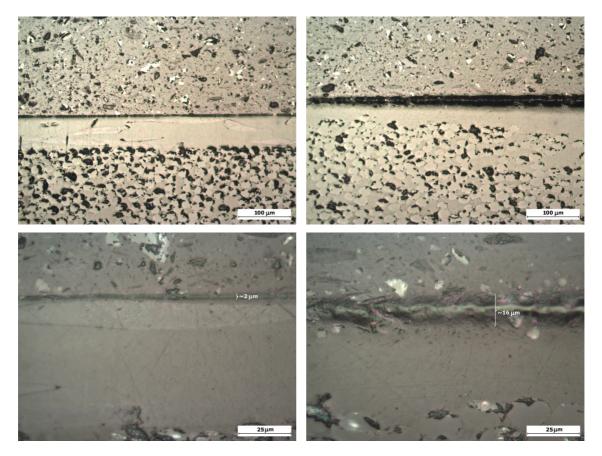
**Figure 8.** Microscopy samples for interphase chemical adhesion: Coat 1, i.e. cured (left) and Coat 2, i.e. tack (right) (zooming: x100 upper images and x400 lower images)

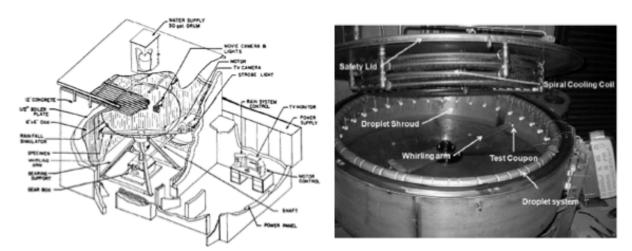
**Figure 9.** Rain test facility at University of Dayton Research Institute, developed for aerospace applications (left) [11] . WARER at University of Limerick (right) [14].

The rain erosion testing was conducted in the University of Limerick's whirling arm rain erosion facility (WARER), which is described by Tobin *et al.* [14], [15]. The test procedure, which is based on ASTM G73-10 [12], evaluated the two coatings at impact speeds up 135 m/s in an artificially generated rainfall with a rate of 25.4 mm/h. The evolution of damage was monitored through mass loss and visual examination of the specimen surfaces. The results were obtained from samples of laminate substrate with two layer biaxial epoxy-GF, 0.7 mm thick and a gel coat layer of 0.3 mm. The circular coupons had a diameter of 27 mm, with an overall thickness of approximately 1.7 mm.

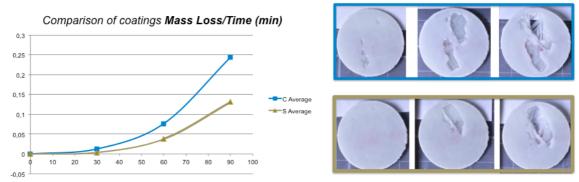
**Figure 10.** Average mass loss versus time for two different coatings: Coat 1 i.e. Cured (C in blue) and Coat 2 with tack (S in Green) (left). Images of surface damage after 30, 60 and 90 minutes of testing.

The eroded samples are shown in Fig. 10. It is evident that the samples manufactured with a higher degree of cure performed worse in regard to erosion compared to those that had a lower degree of cure.

In this work, the mechanical characterization of coat-laminate interphase, which depends on processing (curing) conditions, has been investigated. The rain erosion testing indicated that samples manufactured with a higher degree of cure (as determined using DSC), performed worse in regard to erosion compared to those that had a lower degree of cure. These results correlate with the peeling tests where the moulded coating had a lower value of the force of failure for interphase adhesion testing.
